# COMANCHE GEAR

## MAIN LANDING GEAR SIDE BRACE SUPPORT AND STUD ASSEMBLIES

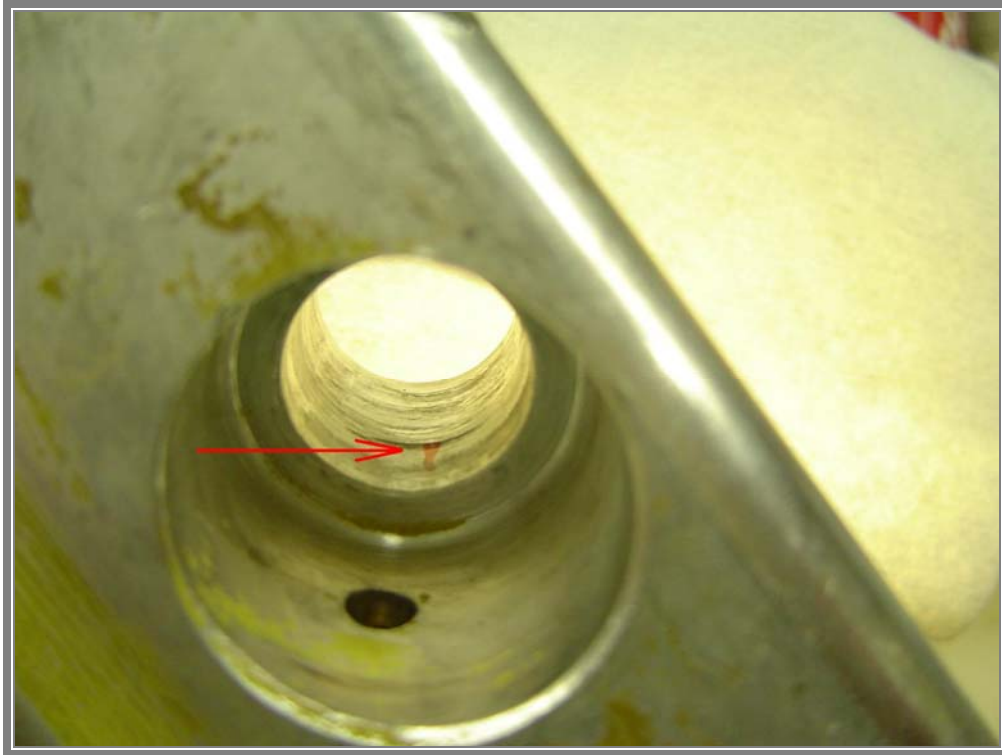
**IN THIS PHOTO YOU CAN SEE THE DAMAGED BORE IN THE FORGING; THE RED MARK [ARROW] SHOWS WHERE THE BUSHING WAS “WORKING”. THIS WAS PROBABLY CAUSED BY IMPROPER REMOVAL AND INSTALLATION OF THE NEW BUSHINGS; ALIGNMENT IS CRITICAL DURING ASSEMBLY.**

WHEN REPLACING THE BUSHINGS BE AWARE THAT HEATING THE ALUMINUM BEFORE REMOVAL AND INSTALLATION IS IMPORTANT, OTHERWISE IT IS POSSIBLE TO DAMAGE THE FORGING BORE, AND THE RESULT CAN BE THE NEW BUSHING MAY NOT HAVE THE REQUIRED FIT. THESE FORGINGS WERE BRUTALLY EXPENSIVE [\$448] IN 1998 WHEN PIPER DISCONTINUED THEM; BE CAREFUL, THEY ARE CURRENTLY NLA AND YOU MAY BE STUCK WITH AN UNKNOWN SALVAGE PART. ALSO IMPORTANT TO KNOW, AFTER INSTALLATION OF THE NEW **BUSHINGS** IN THE SIDE BRACE SUPPORT, THEY WILL REQUIRE REAMING TO SIZE AND FOR HOLE ALIGNMENT; THAT'S WHY PIPERS' BUSHINGS ARE UNDER-SIZE ON THE I.D. WHY **BUSHINGS** - IT IS INAPPROPRIATE TO REPLACE JUST ONE; YOU WILL NEVER HAVE ALIGNMENT OF THE INTERNAL BORES UNLESS YOU REPLACE BOTH IN ONE BRACKET, FOLLOWED BY THE REAMING OPERATION. YOU MUST REAM THEM OR THE INTERNAL BORES WILL NOT BE IN ALIGNMENT; THINK ABOUT IT! IN ADDITION I USE A HONE AFTER REAMING TO IMPART A CROSS-HATCH FINISH FOR BETTER LUBRICITY.

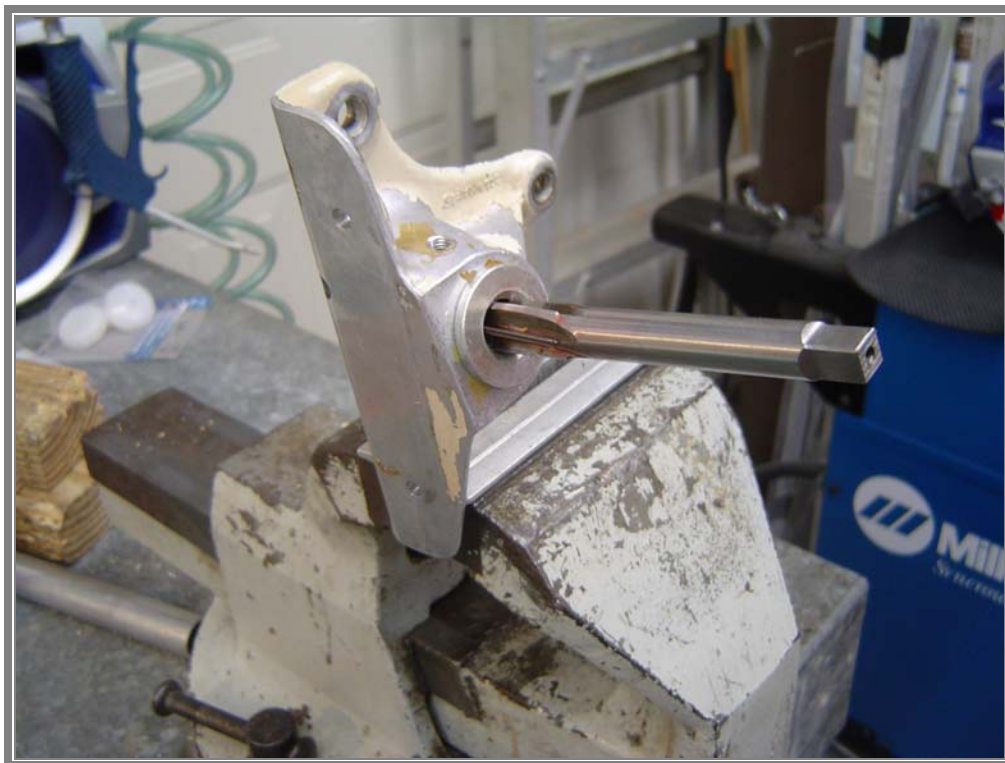
**REAMING THE BUSHINGS’ INSIDE DIAMETER TO SIZE AND ALIGNMENT.**

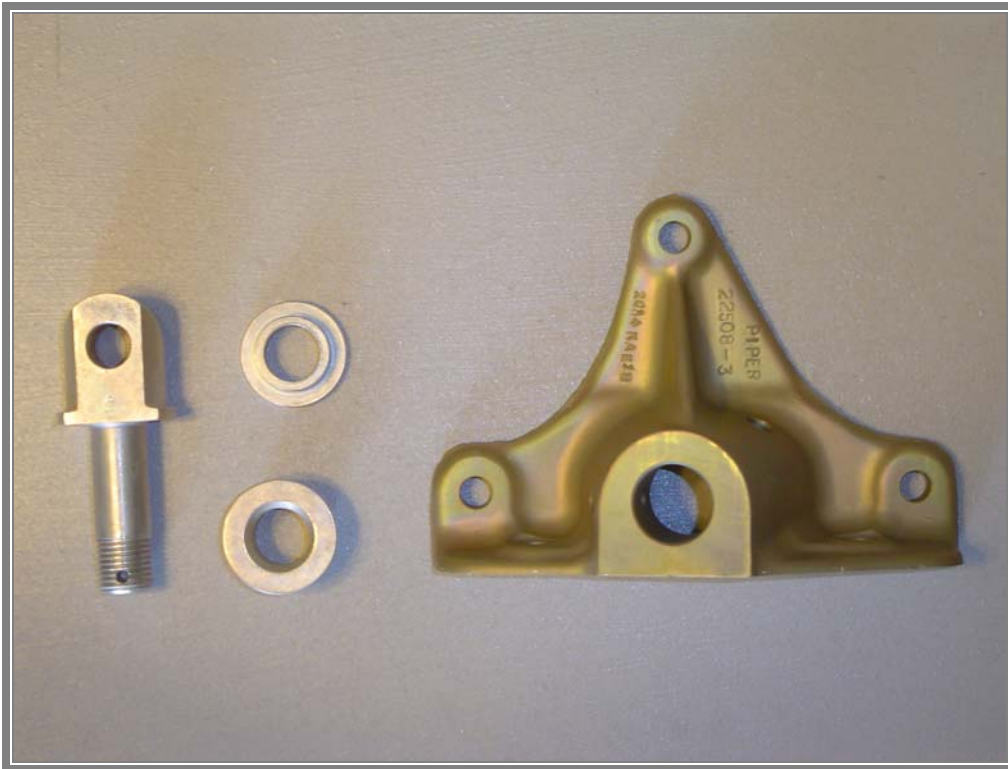
**SIDE BRACE SUPPORT GLASS BEAD BLASTED AND ALDODINE® TREATED;  
SIDE-BRACE STUD AD COMPLIED WITH [YT] AND NEW PIPER BUSHINGS.**

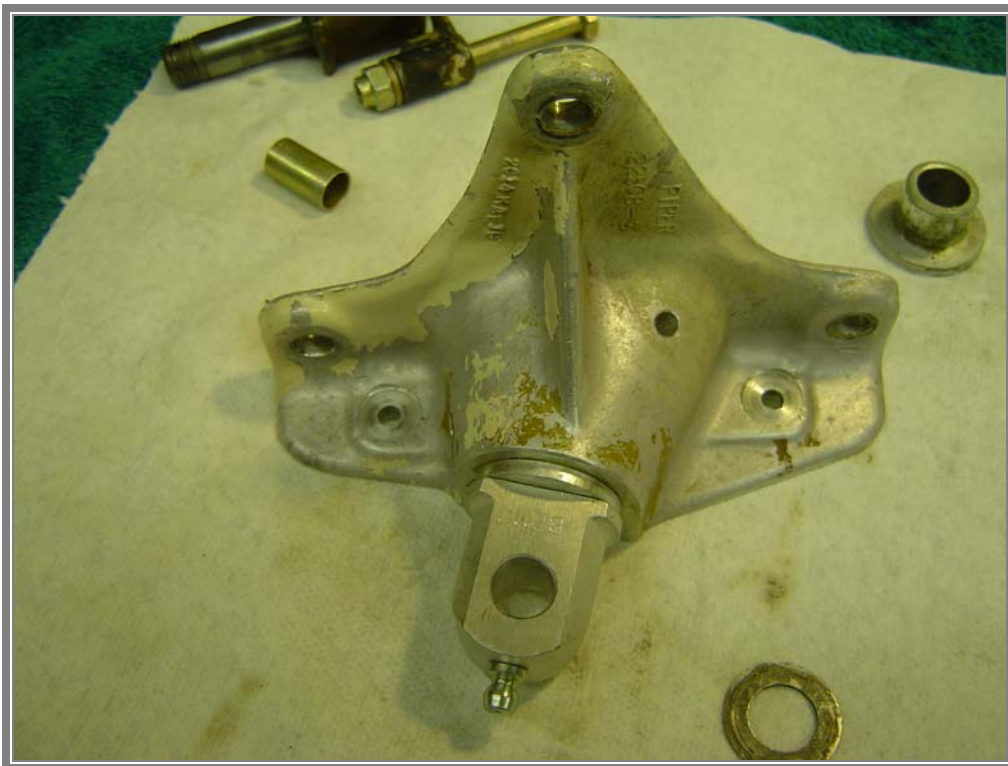
**ANOTHER SIDE BRACE SUPPORT ASSEMBLED AND YELLOW TAGGED;  
THIS ASSEMBLY HAS A NEW STUD AND BUSHINGS, NO COSMETICS.**
