# COMANCHE GEAR

## 400 COMANCHE INDUCTION HOUSING

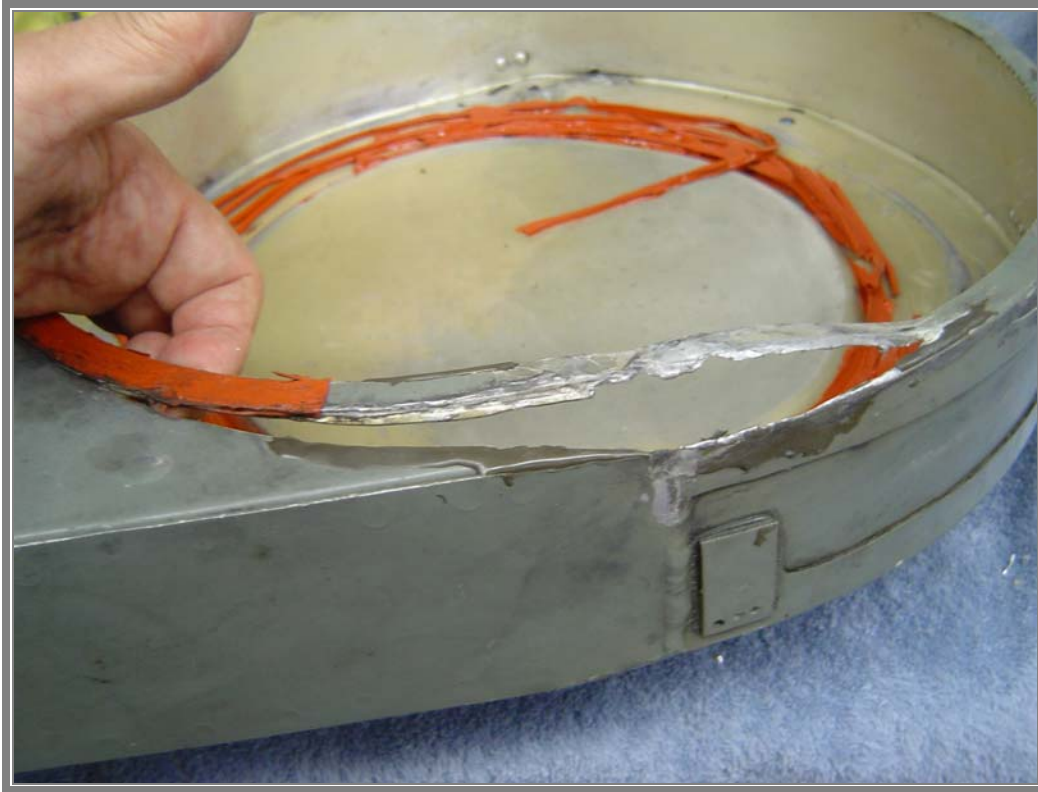
THE 400 COMANCHE INDUCTION HOUSING ASSEMBLY CONSISTS OF TWO SUB ASSEMBLIES, 24568-000 THE BOX ASSEMBLY AND 24569-000 THE PLATE ASSEMBLY. BOTH OF THESE PART NUMBERS HAVE BEEN DELETED FROM PIPER'S AVAILABILITY LIST; THEIR 1999 PRICING WAS \$1800 AND \$550. THESE COMPONENTS TEND TO SUFFER THE RIGORS OF FRETTING, CRACKING AND FROM LACK OF MAINTENANCE TO THE CAMLOC® LATCHES WHICH CLAMP THE TWO COMPONENTS TOGETHER. THIS POOR CLAMPING RETENTION LEADS TO FURTHER FAILURE AND SUBSEQUENTLY A POSSIBLE POOR CHOICE OF REPAIR METHOD, THE THROUGH-BOLT METHOD IS ONE. TYPICALLY BOTH PIECES REQUIRE SUBSTANTIAL WORK AFTER 42+ YEARS OF FRETTING DAMAGE.

**24568-000 BOX ASM, AS RECEIVED.**  
**NOTICE THE PRIOR "REPAIRS" USING EPOXY AND SILICONE**

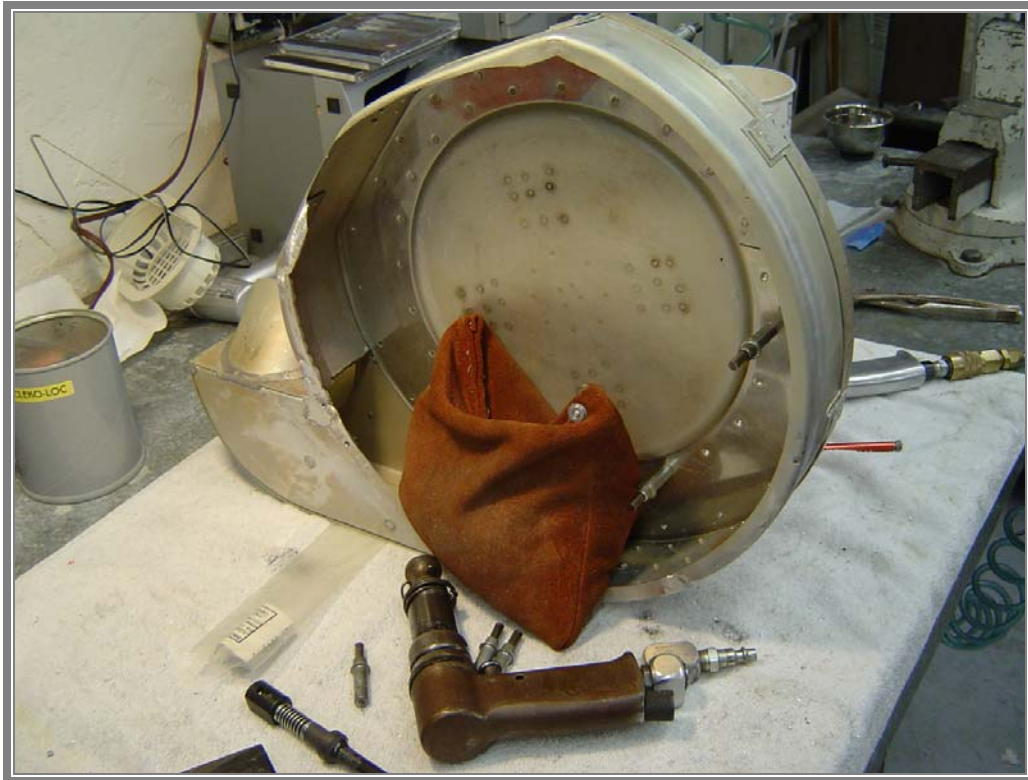
**24568-000 BOX, TYPICAL REPAIR PROCESS**

THE PLATE ASSEMBLY WILL BE REPAIRED AND REINFORCED TO BETTER SUPPORT THE BOX ASSEMBLY AND THE BOX ASSEMBLY ITSELF REPAIRED AS NECESSARY. ADDITIONAL SEALING AND VIBRATION/FRETTING RESISTANCE ARE ADDED USING SILICONE FOAM RUBBER BETWEEN THE TWO COMPONENTS AT THE MATING SURFACE AND THIN ANTI-CHAFE TAPE AT THE BOX CIRCUMFERENCE. SO FAR I HAVE BEEN ABLE TO PURCHASE THE CAMLOC® LATCH ASSEMBLIES AND STRIKES THAT PIPER ORIGINALLY USED, ALTHOUGH REPORTEDLY THEY HAVE BEEN DISCONTINUED, SO WHO KNOWS WHAT THE FUTURE BRINGS IN THAT DEPARTMENT.

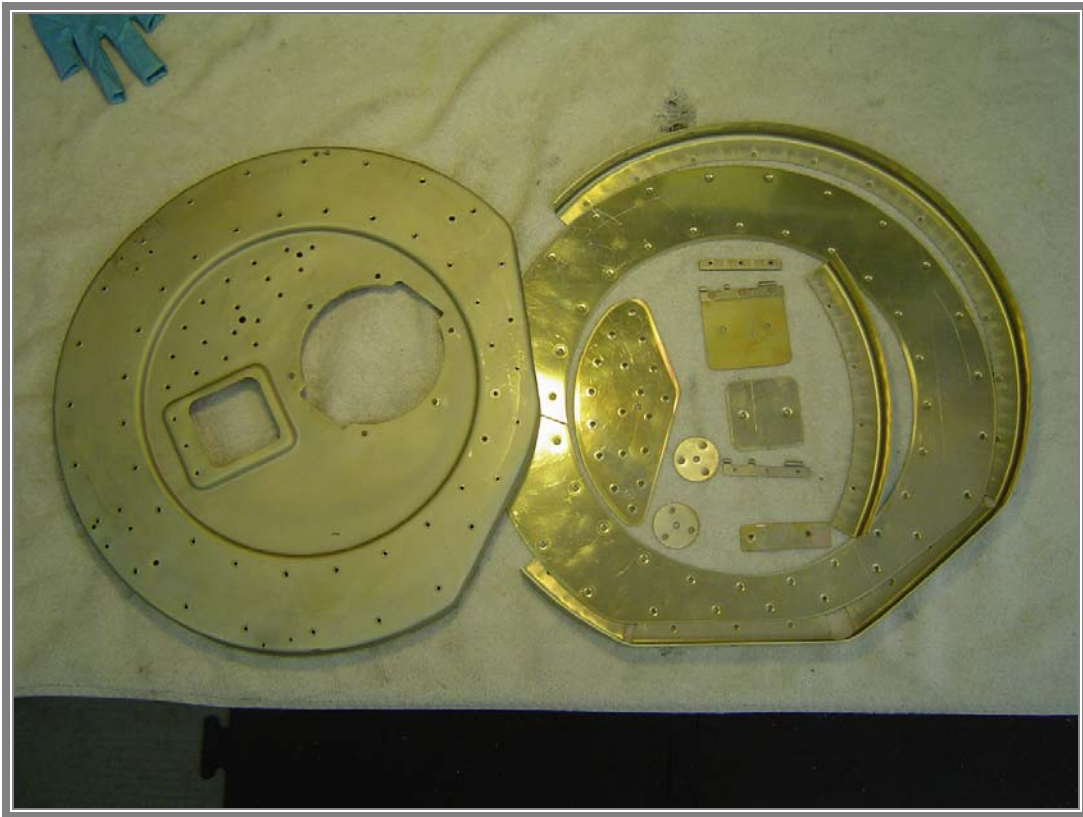
24569-000 PLATE, TYPICAL REPAIR COMPONENTS
