**FIGURE 8-8. FIVE POSITION FUEL VALVE
PA-24-250 and PA-24-260**

8-15. Servicing Five Position Fuel Valve (Hoof). (PA-24-250 and PA-24-260) Normally the five position valve need only be serviced when there are indications of binding or leakage around the valve shaft (1, Figure 8-8), at the mating surface of the upper valve body (10) and lower valve body (6) or if reason to believe that there is leakage through the valve when in an off position. Replacement of "O" rings will usually correct this condition.

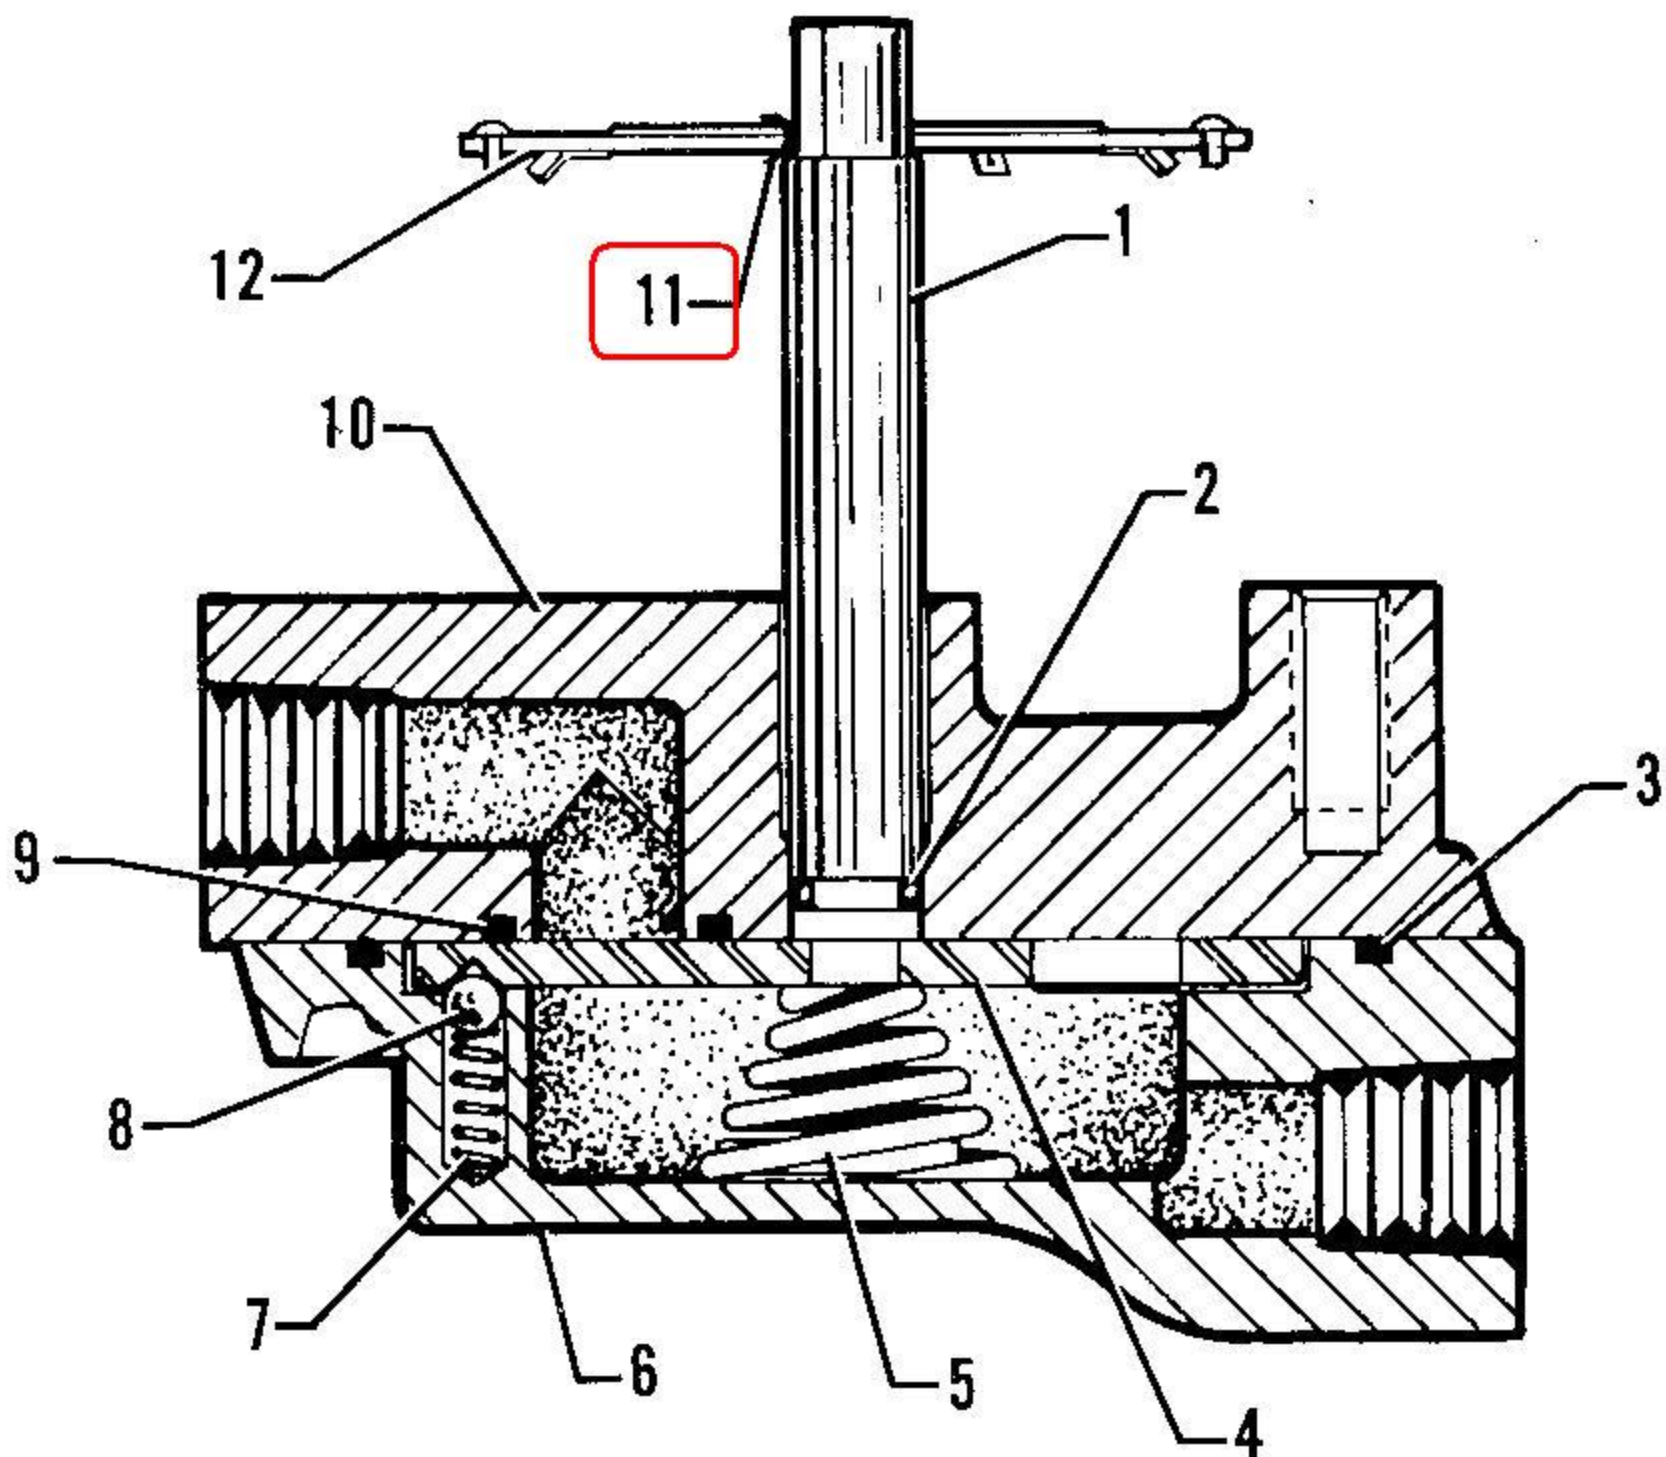
| 1. VALVE SHAFT | 7. BALL SPRING |
| 2. "O" RING | 8. CHECK BALL |
| 3. SEAL | 9. "O" RING |
| 4. VALVE PLATE | 10. UPPER VALVE BODY |
| 5. PLATE SPRING | 11. TAPE |
| 6. LOWER VALVE BODY | 12. SWITCH |

a. With the valve assembly removed from the aircraft, remove the safety wire and disassemble the valve assembly.

b. Check the shaft hole of the valve body (10) where the "O" ring (9) makes contacts for roughness that might damage the "O" ring. Polish the hole surface to remove any roughness.

c. Ascertain that the valve plate (4) is not warped and the plate surface toward the shaft side is not scored, allowing O-rings to be damaged.

d. Inspect the plate detents, ball (8) and spring (7) to determine that the ball will operate properly in the plate detents.

e. Lubricate the O-rings with engine oil, reassemble the valve and safety.
