# COMANCHE GEAR

## MAIN LANDING GEAR SIDE BRACE SUPPORT AND STUD ASSEMBLIES

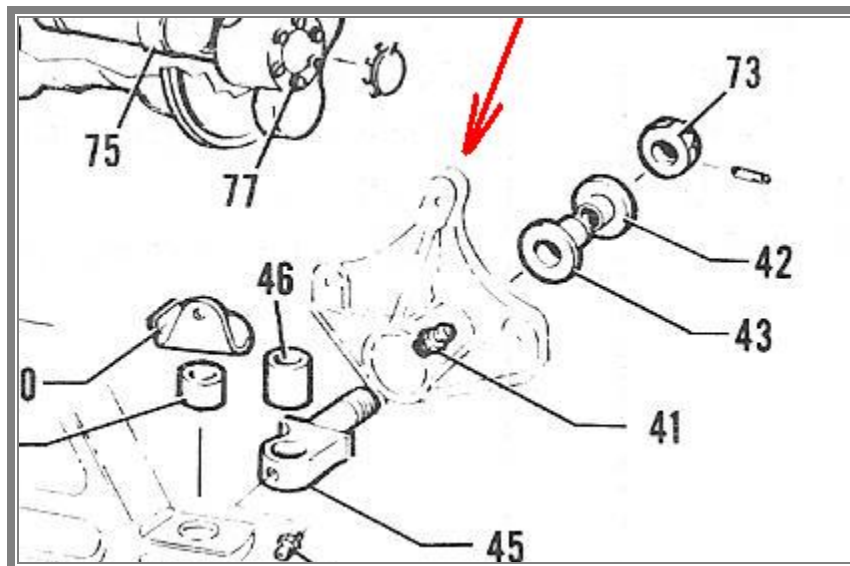
**IN THIS PHOTO YOU CAN SEE THE DAMAGED BORE IN THE FORGING; THE RED MARK [ARROW] SHOWS WHERE THE BUSHING WAS “WORKING”. THIS WAS PROBABLY CAUSED BY IMPROPER REMOVAL AND INSTALLATION OF THE NEW BUSHINGS; ALIGNMENT IS CRITICAL DURING ASSEMBLY.**

WHEN REPLACING THE BUSHINGS BE AWARE THAT HEATING THE ALUMINUM BEFORE REMOVAL AND INSTALLATION IS IMPORTANT, OTHERWISE IT IS POSSIBLE TO DAMAGE THE FORGING BORE, AND THE RESULT CAN BE THE NEW BUSHING MAY NOT HAVE THE REQUIRED FIT. THESE FORGINGS WERE BRUTALLY EXPENSIVE [\$448] IN 1998 WHEN PIPER DISCONTINUED THEM; BE CAREFUL, THEY ARE CURRENTLY NLA AND YOU MAY BE STUCK WITH AN UNKNOWN SALVAGE PART. ALSO IMPORTANT TO KNOW, AFTER INSTALLATION OF THE NEW **BUSHINGS** IN THE SIDE BRACE SUPPORT, THEY WILL REQUIRE REAMING TO SIZE AND FOR HOLE ALIGNMENT; THAT'S WHY PIPERS' BUSHINGS ARE UNDER-SIZE ON THE I.D. WHY **BUSHINGS** - IT IS INAPPROPRIATE TO REPLACE JUST ONE; YOU WILL NEVER HAVE ALIGNMENT OF THE INTERNAL BORES UNLESS YOU REPLACE BOTH IN ONE BRACKET, FOLLOWED BY THE REAMING OPERATION. YOU MUST REAM THEM OR THE INTERNAL BORES WILL NOT BE IN ALIGNMENT; THINK ABOUT IT! IN ADDITION I USE A HONE AFTER REAMING TO IMPART A CROSS-HATCH FINISH FOR BETTER LUBRICITY.
